A STATISTICAL TRAFFIC ACCIDENT ANALYSIS

A. ASBERG, Head, Analysis Section
Volvo Passenger Car Division VTC
AB Volvo

INTRODUCTION AND ABSTRACT

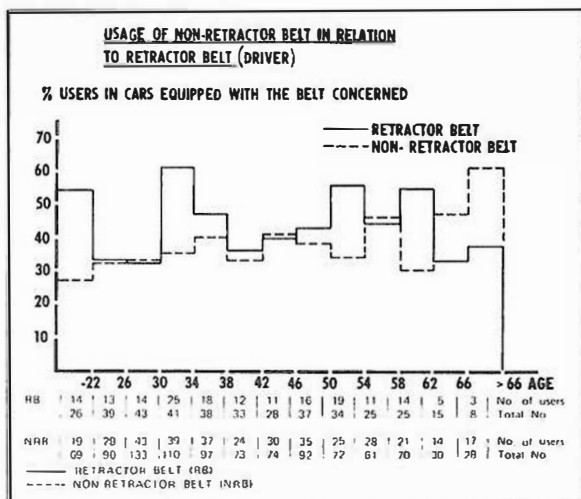
Figure 4

still more cooperative (50.3%), an improvement of 30%. The frequency of use of the retractor belt showed no noticeable relationship to age distribution (Figure 4). In fact, the retractor belt showed a lower use frequency, as compared with the non-retractor belt for the age of 62 years. It might be explained simply by the comparatively small number of observations, or it could be the effect of pressure of the upper torso strap on the chest, which older people could find irritating.

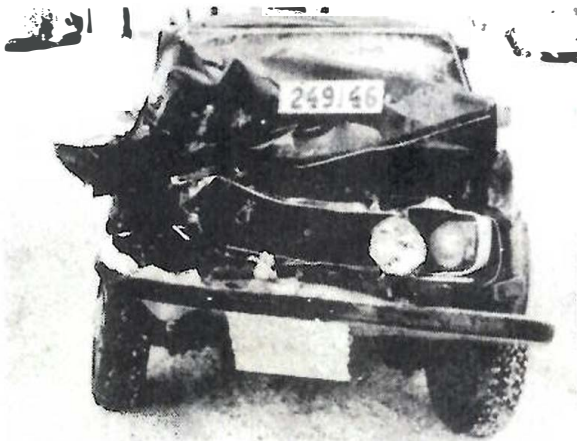
Accident No. 1

Cause of death: chest injuries.

Safety belt: unknown, but probably not used.

Collision speed: below 50 km/h; estimated on extent of deformation VDI 12FRXA6, VID I, 0.

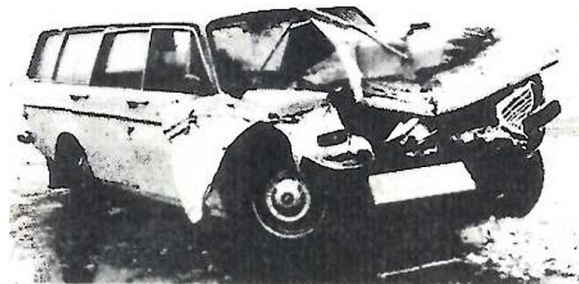
Accident No. 2

Collision speed: below 50 km/h; estimated on extent of deformation. VDI 12 FZEW 3, VID I FS10100.

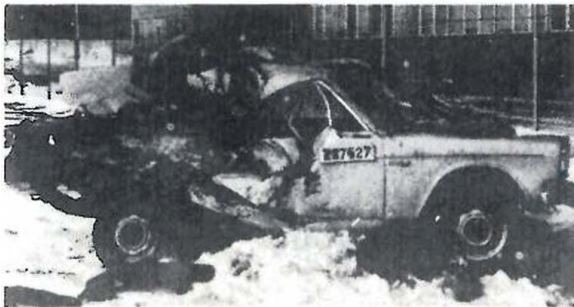
Accident No. 3

1. Severity of accident (see Item 4) was of such extent that influence of interior design can be disregarded.
D 4
2. Driver was thrown from left to right side; can be presumed that had seat belt been used, would have had effect.
D 2
3. Not applicable.
D 5
4. Speed of skidding car was between 70 – 90 km/h; speed of approaching truck was 70 km/h, implying that conditions of VESC requirement were exceeded.
D 3
5. Not applicable.
D 5
6. Not applicable.
D 5
7. Not applicable.
D 5

Remarks: Driver, sole occupant, killed.

Cause of death: head injury.

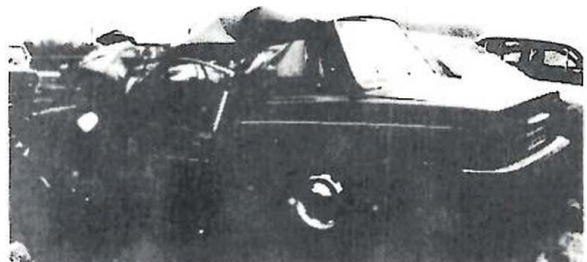
Accident No. 4

1. Severity of accident (see Item 3 below) was of such extent that influence of interior design can be disregarded.
D 4
2. Use of safety belt would have had very limited effect, due to intrusion by truck platform and extensive deformation of the roof.
D 3
3. Of no importance in this type of accident. Underrunning a stationary truck; speed 90 – 100 km/h
D 4
4. Not applicable.
D 5
5. Not applicable.
D 5
6. Not applicable.
D 5
7. Not applicable.
D 5

Remarks: Driver, sole occupant, killed.
 Cause of death: head injury.
Joint appraisal of occupant and accident vehicle.
 Safety belt: not used.
 Collision speed: approximately 100 km/h; based on witness reports.
 VDI 2FDXA7. VIDI FS31390.

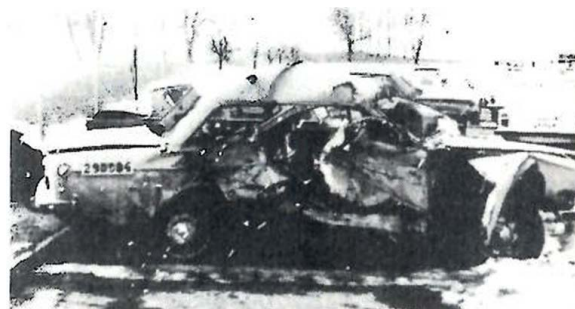
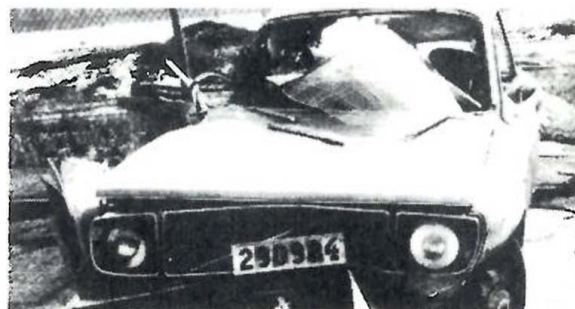
Accident No. 6

Volvo 142/1972. Type of accident: run into on rightside by normal-control truck.

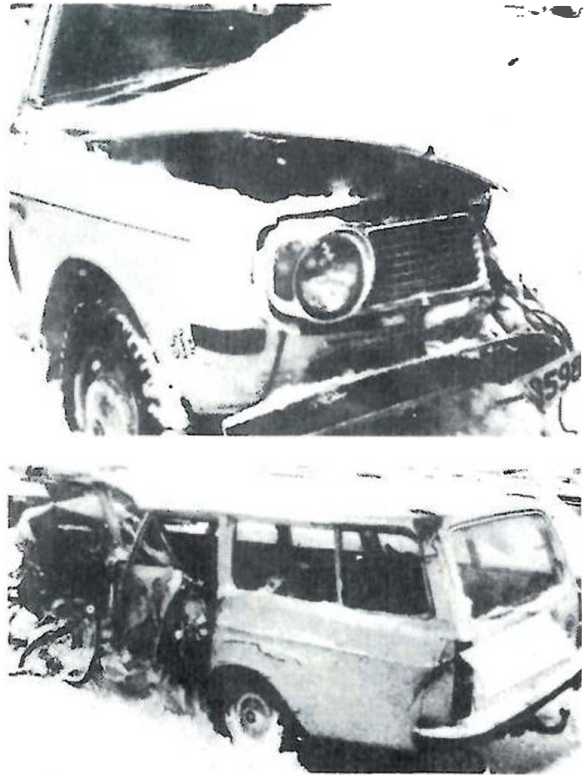
Accident No. 7

VDI 11LYES3 1 2RDES1 00TDS01. VIDI LS 21333.

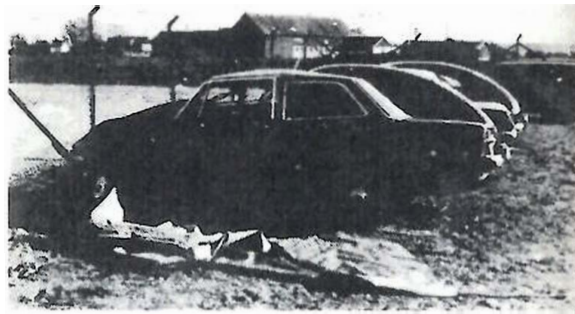
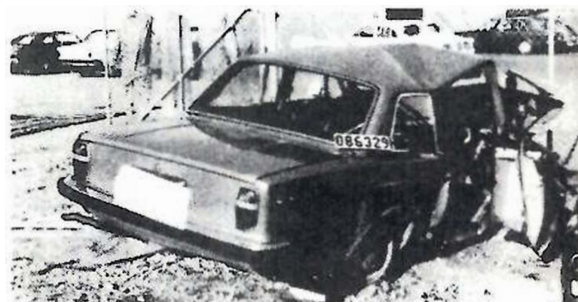
Accident No. 9

Cause of death: chest injuries

VDI 01FZEW5. VIDI RS20330.

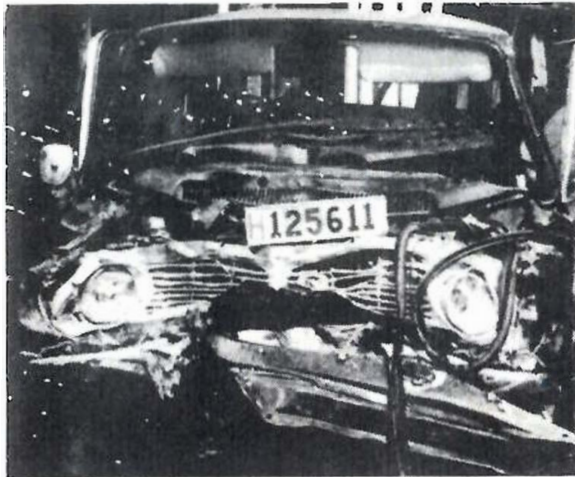
Accident No. 10

VDI 12FDEW5. VIDI FS30350.

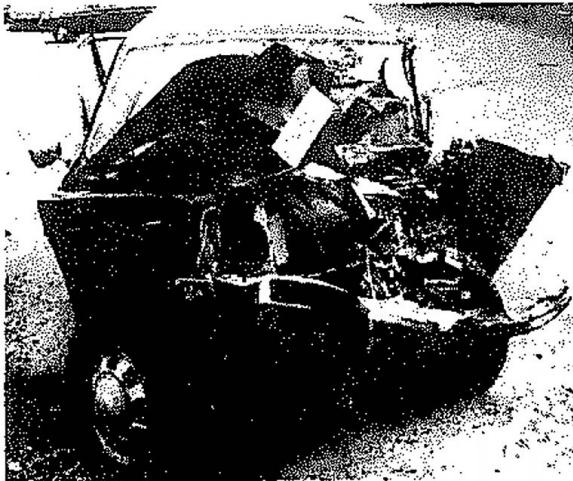
Accident No. 12

Remarks: Front seat passenger, and six-month-old boy lying on his mother's knee in rear seat, were killed. Other occupants, four persons, of which the driver was belted, escaped serious injury.

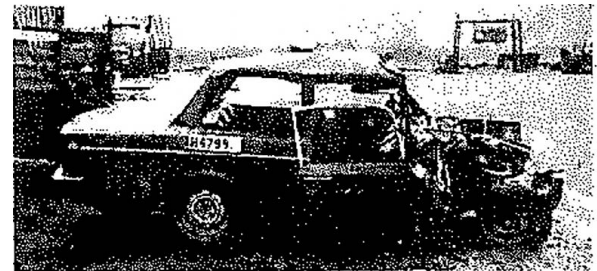
Accident No. 13

Volvo 142/1968. Type of accident: frontal collision (11.30) with approaching truck of forward-control type.

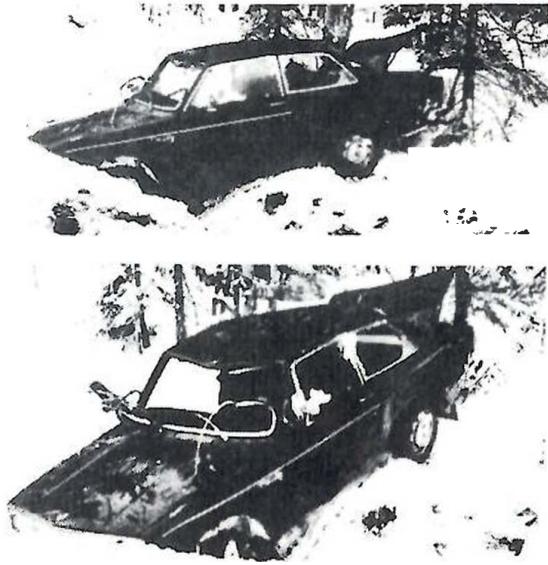
Accident No. 14

Volvo 142/1969. Type of accident: ran off road into ditch and turned over.

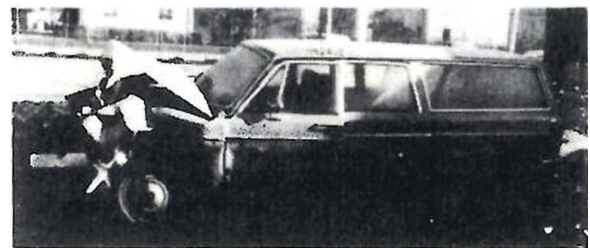
Accident No. 15

Volvo 145/1971. Type of accident: head-on collision (12 o'clock) with approaching vehicle.

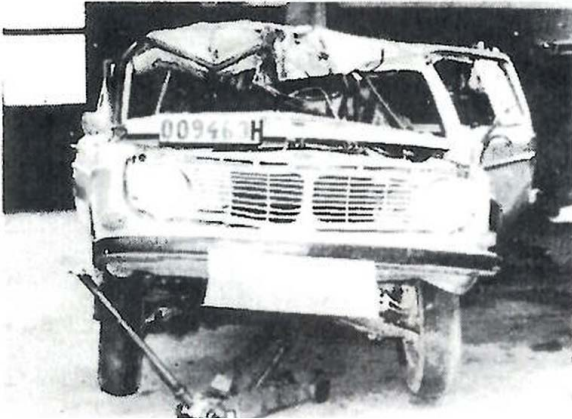
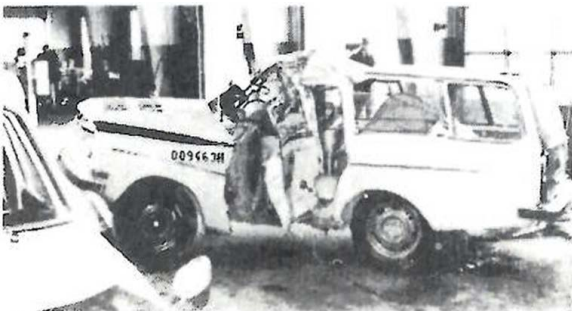
Accident No. 16

Volvo 145/1969. Type of accident: skidded against tree, left side first.

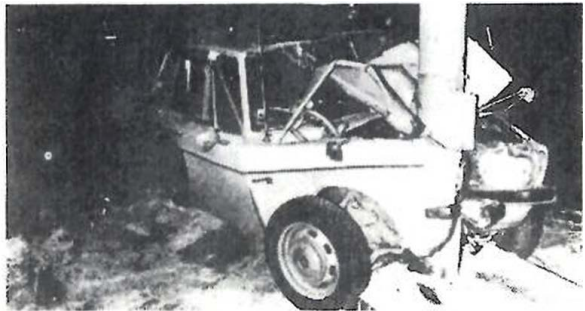
Accident No. 17

Volvo 144/1970. Type of accident: head-on collision with pole (12 o'clock).

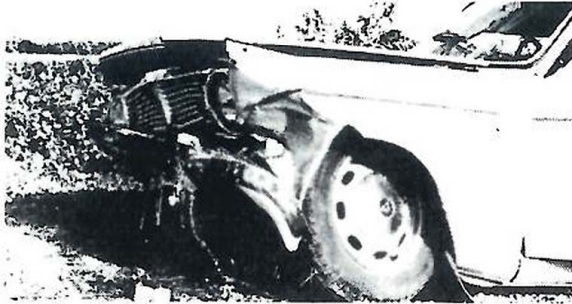
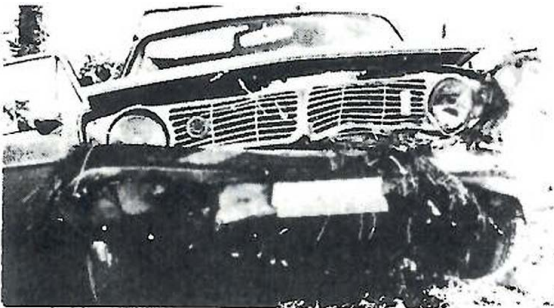
Accident No. 19

Safety belt: not used.
 Collision speed: approx. 70 km/h, according to witnesses.
 VDI 12FDLW1. VIDI 0.

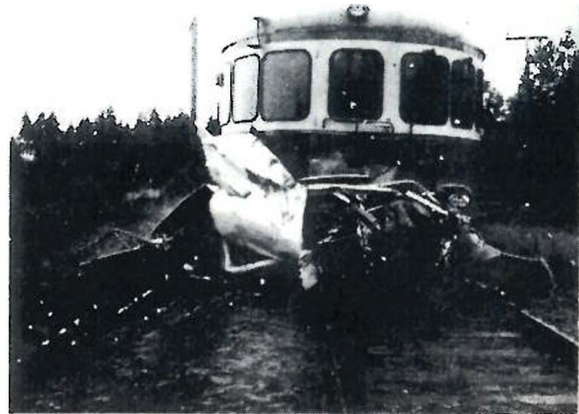
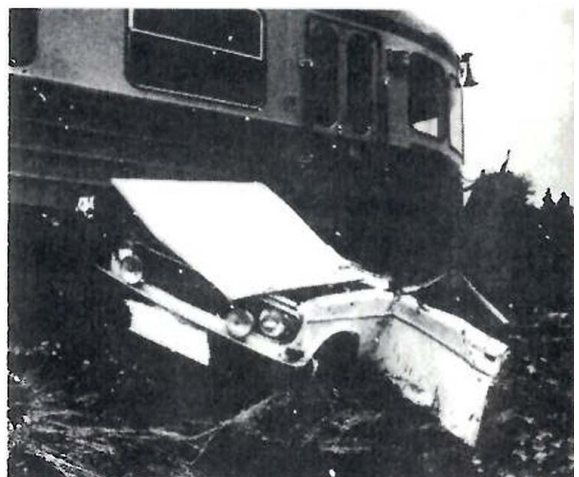
Accident No. 20

Collision speed: rail bus, 110 km/h, substantiated information.
 VDI 03X. VIDI AS X.

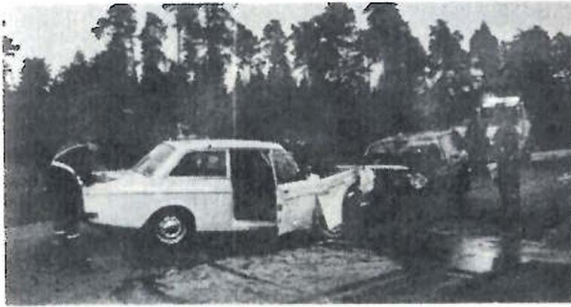
Accident No. 21

Remarks: driver, sole occupant, killed.
Cause of death: chest and abdominal injuries.
Joint appraisal of occupant and accident vehicle.
Safety belt: not used.
Collision speed: below 50 km/h; estimated on extent of deformation.
VDI 11 FDEW1. VDI 0.

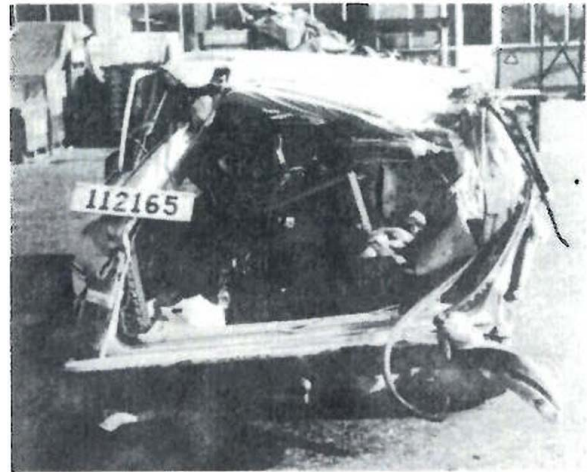
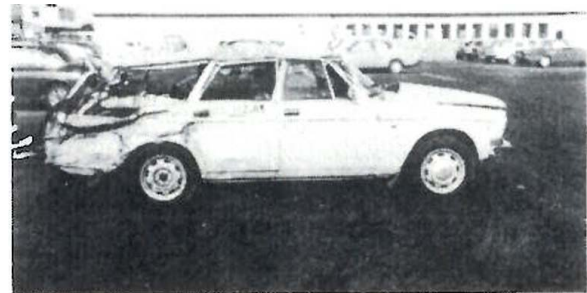
Accident No. 22

Collision speed: Volvo 145, 70 km/h; other car, approx. 50 km/h, according to drivers.
VDI 03RBEW2 00TDAO1. VDI RS01000.

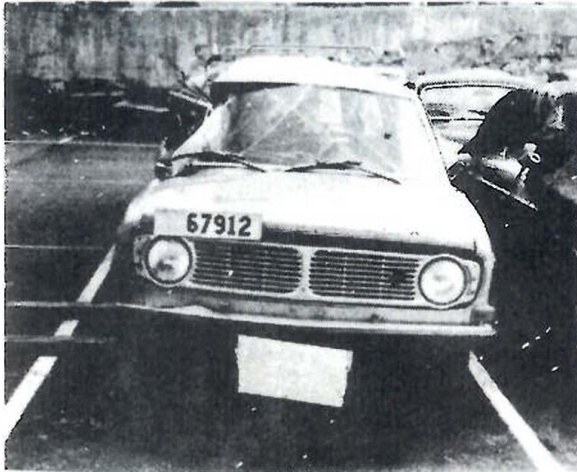
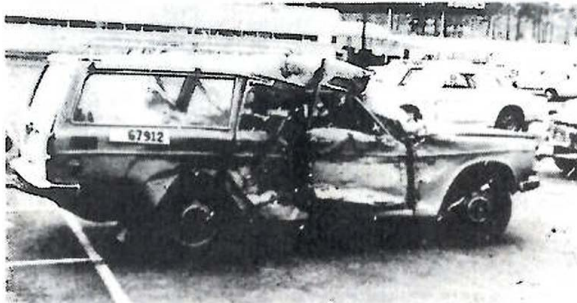
Accident No. 23

Remarks: Front seat passenger killed.
Cause of death: chest injuries.
Joint appraisal of occupant and accident vehicle.
Safety belt: (unknown)
Joint Appraisal of occupant and accident vehicle.
Collision speed: bus, approx. 50 km/h.
VDI 03RPAW3. VIDI RS00003.

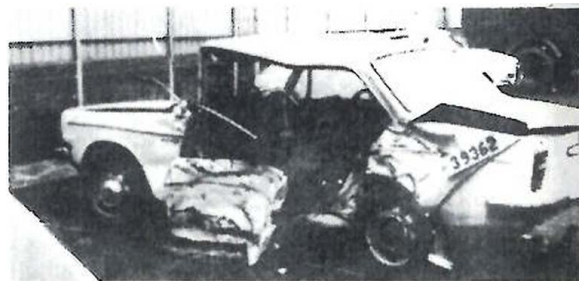
Accident No. 24

Remarks: Driver, sole occupant, killed; found after accident lying beside his vehicle.
Cause of death: chest and abdominal injuries.
Joint appraisal of occupant and accident vehicle.
Safety belt: not used
Collision speed: Volvo 142, unknown; other car, 60 km/h, according to driver.
VDI 11LPES 3. VIDI LS10003.

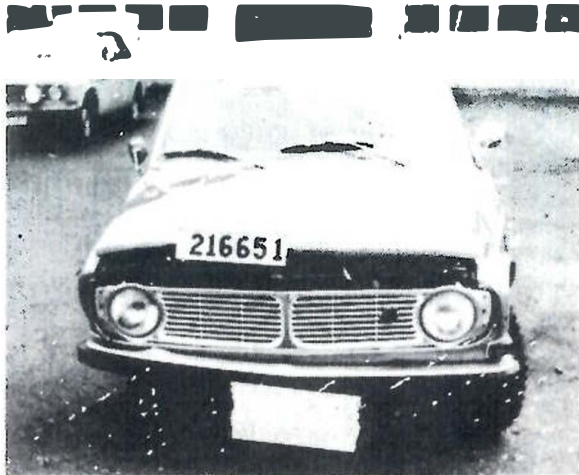
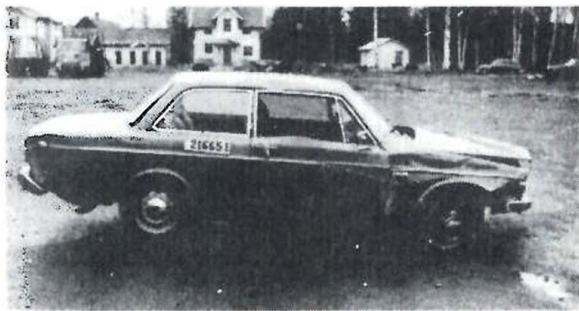
Accident No. 25

Remarks: driver, sole occupant, killed.
Cause of death: head injuries.
Joint appraisal of occupant and accident vehicle.
Safety belt: not used.
Collision speed: unknown.
VDI 00TDAO 1. VIDI 0.

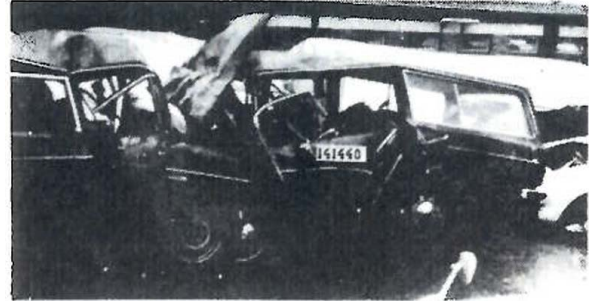
Accidents Nos. 26, 27

VDI 12 FDAW 7. VIDI FS 41590.

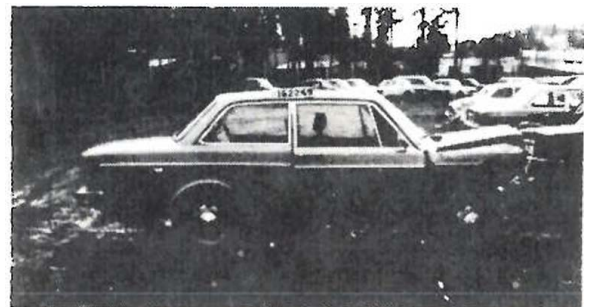
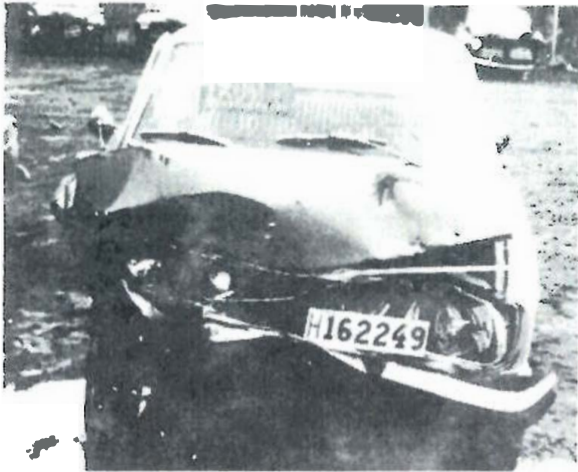
Accident No. 28

1. Personal injuries due to contact with steering wheel.
D 1
2. Correctly used safety belt would have had effect.
D 1
3. Collision speed below 50 km/h.
No reduction of passenger compartment.
D 4
4. Not applicable.
D 5
5. Not applicable.
D 5
6. Not applicable.
D 5
7. Not applicable.
D 5

Remarks: Driver was killed; passenger escaped serious injury.

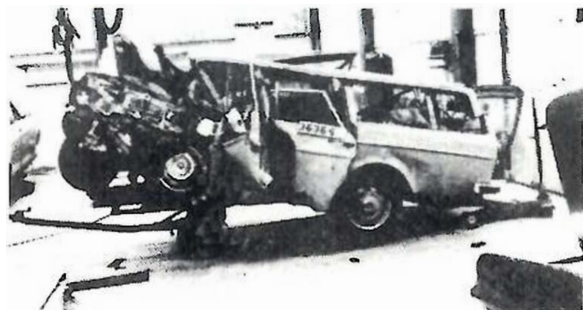
Accident No. 29

VDI 11 FDEW 7. VIDI LF40492.

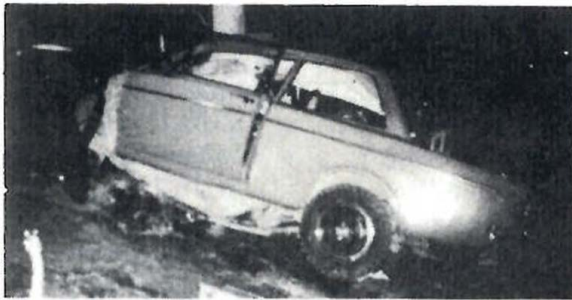
Accident No. 30

VDI 01 RYAN 3. RF 32222 LF 11000.

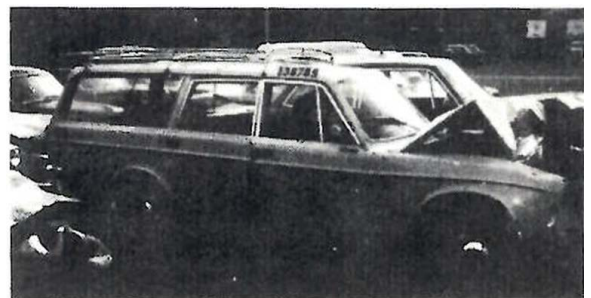
Accident No. 31

VDI 12 FDEW 2. VIDI 0.
