Thoracolumbar Spine Injuries in Car Crashes

Lotta Jakobsson, Magnus Björklund, Anders Westerlund

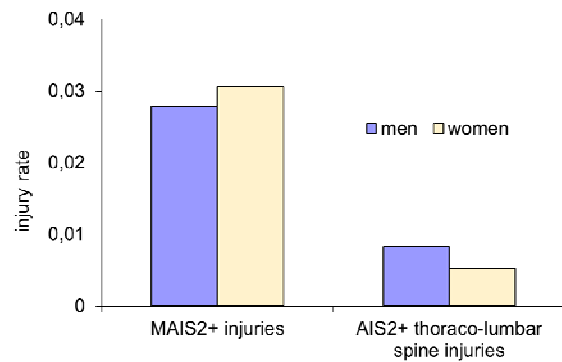
Figure 4 displays the injury rates, comparing men and women, and the overall injury rates (MAIS2+) to AIS2+ TL spine injury rates. It can be seen that the trend of AIS2+ TL spine injury rate deviates from the overall MAI2+ injury rate trend. There is a tendency for higher MAIS2+ rate for women as compared to men, while for the group of AIS2+ TL spine injuries an opposite tendency is seen.

Fig. 4. MAIS2+ injury rates and AIS2+ thoracolumbar spine injury rates, comparing gender.

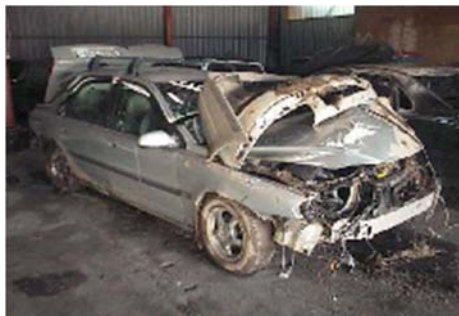
In **Case 1**, a restrained male driver aged 40 was driving his Volvo S80 (year model 2000) on a rural road with speed limit of 90 km/h. It was daytime, and the road was partially slippery due to ice. Suddenly, a deer appeared on the road. He tried to steer out of the collision path, but lost control of the car and ran off the road to the right and into a ditch, followed the ditch and ran into an embankment of a crossing road. Due to the interaction with the sloping embankment, the vehicle got into a turnover and ended up on its right side. Main interactions are seen at the undercarriage (Fig. 11). The driver sustained an AIS2 compression fracture on the L1 vertebra. In addition, he sustained pain in the chest, right knee and right elbow and a contusion on his nose (all of AIS1). The mechanism behind the lumbar spine fracture is likely axial loads, most probably occurring when impacting the embankment.

Fig. 11. Vehicle in Case 1, run-off-road crash.

addressing reduced occupant vertical acceleration, such as that typically occurring in case 1 of this study. Together with sensing and occupant retention functionalities, the seat was included in a run-off-road protection package that was put in production in 2015 [21], with the target of reducing the occurrence of vertical load-induced TL fractures.

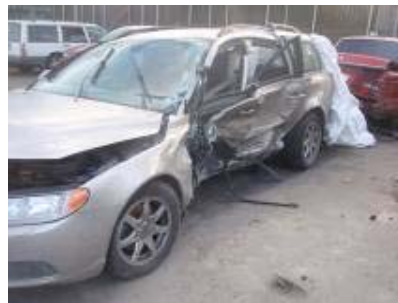
Fig. 12(a). Exterior view of vehicle in Case 2, side impact.

In **Case 2**, a restrained male driver aged 19 was driving a V70 (year model 2011) on a slippery rural road early in the morning in winter darkness. Usually he drove another car, but it was at the workshop on this particular day. The speed limit of the road was 80 km/h. The driver was in a hurry because he was late for an appointment. He approached two cars, which were driving slowly, and decided to overtake these cars. When doing that, he failed to steer back into lane. Instead, the car began skidding, exposing the left side towards opposing traffic. At that time a KIA Ceed was approaching in the opposite lane. The KIA impacts frontally into the Volvo's driver door area with an angle slightly forward. During the crash, the SIPSbag (torsobag), the Inflatable Curtain and the torso and lap-belt pretensioners activate in the Volvo car. The maximum residual interior intrusions laterally in the area of the seat cushion are 29 cm (rear) and 35 cm (front), respectively. The Volvo driver was taken to hospital, where he remained in intensive care for a week. He sustained an AIS2 compression fracture on the L4 vertebra, which was most displaced in its left ventral part. In addition, he sustained an AIS3 splenic rupture, AIS2 pelvic fractures, a left transverse process fracture on L3 (AIS2), sprain in the left shoulder (AIS1) and concussion with loss of consciousness (AIS2). The mechanism behind the compression lumbar spine fracture is likely axial loads while bending forward slightly to the left, caused by an upward shift of the seat during the intrusion in combination with the lap-belt-pelvis interaction during the ride-down. This hypothesis is supported by the ramus inferior os pubis fractures, which most likely result from loads transmitted in a direct oblique impact upwards-inwards from stiff structures of the left part of the seat, caused

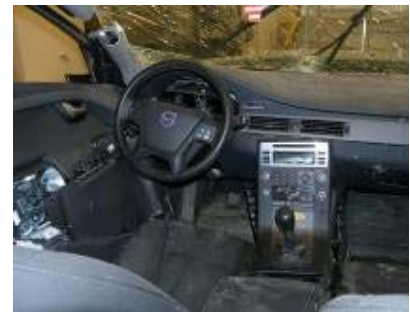
Fig. 12(b). Interior view of driver seat in Case 2.

by the intruding structure (Fig. 12(b)).

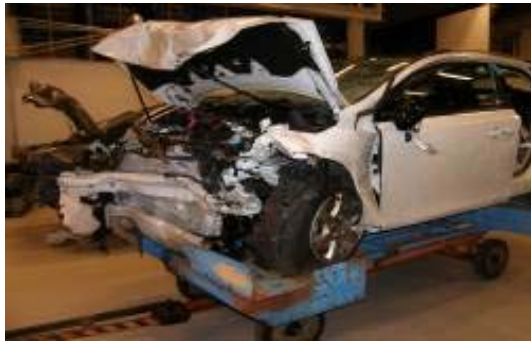
The restrained 44-year-old male driver in **Case 3** was driving a Volvo V40 (2014) on a wet, rural road during the evening, in darkness (Fig. 13(a)). He was driving at approximately 80 km/h when an opposing car, for unknown reason, drifted into his lane (Fig. 13(b)). The driver of the Volvo applied the brakes and reduced the speed by approximately 20 km/h before being impacted by a Peugeot Bipper. The estimated impact speed is 60 km/h (Volvo) and 80 km/h (Peugeot) at approximately 10 degrees and an overlap of 80%. The Volvo driver sustained an AIS2 compression fracture on the L5 vertebra, reduced to approximately 50% of total height (Fig. 13(c)). He was treated with an orthoses. In addition, he sustained a fracture (AIS2) on his right ankle and fractures (AIS2) on the left foot's distal metatarsals 3 and 4, as well as pain (AIS1) in his left thumb. He sustained no injuries to his head or torso. When inspecting the driver seat, deformations on the seat chassis structure, slightly in front of his initial pelvis position, were seen. Although the forces on the vehicle were primarily longitudinal, it is likely that the mechanism behind the lumbar compression spine fracture is axial loads. These are believed to be caused by the pelvis interaction with the seat in combination with the seatbelt interaction.

Fig. 13(a). Vehicle in Case 3, frontal impact.

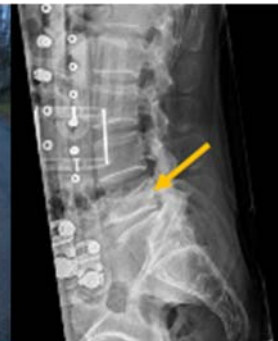
Fig. 13(c). L5 compression fracture in Case 3.
